Ref: RU.23/1639  
Date: 25/03/2024

## BUILT HERITAGE ADVICE

**RE: Longcross Church, Longcross Road, Chertsey, Surrey, KT16 0DU.**

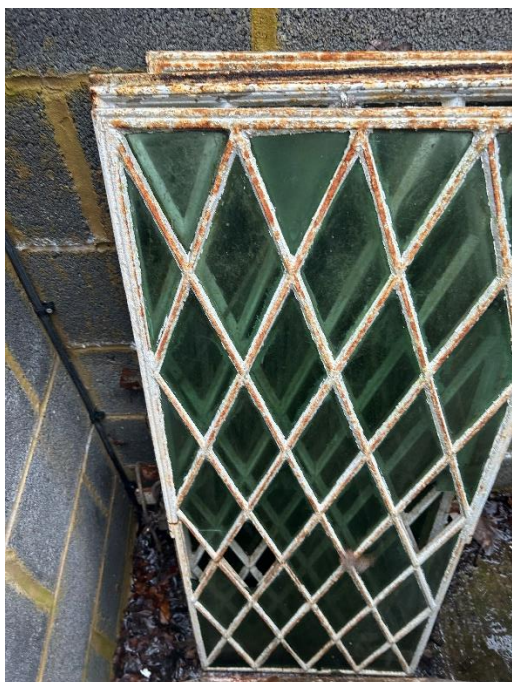
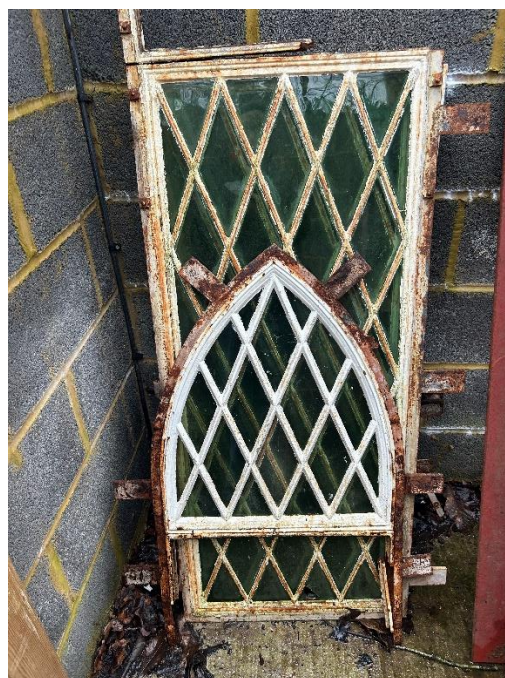
During the site visit, several of the pre-existing windows were available for visual inspection and it is considered that many had elements which could have been repaired and refurbished (see photographs below). Certainly, there was potential for historic glass to have been salvaged and reused in an appropriate manner. In any case, it has not been sufficiently evidenced that all windows were beyond repair or refurbishment to require replacement.

The works to the windows include the wholesale loss of original window frames and leaded light windows, the partial loss of original stained glass, the severing of stained-glass compositions, and the reframing of stained glass within triple-glazed inappropriate and unsympathetic uPVC frames (which have distinctly visual and operational differences that detract from significance). It is also understood that many of the stone dressings to the hood mouldings have been damaged, deconstructed, or removed as part of this process.

In conclusion, it is my professional opinion that the pre-existing windows should be reinstated using as much of the original and historic fabric as possible. Where it is necessary to use new fabric, this should be on a strictly like-for-like basis, wholly reflecting that of the pre-existing windows.
